# Rural R&D for Profit Programme

Smart irrigation: when and how much  
Project 1a  
Final Report

June 2015 - May 2018]

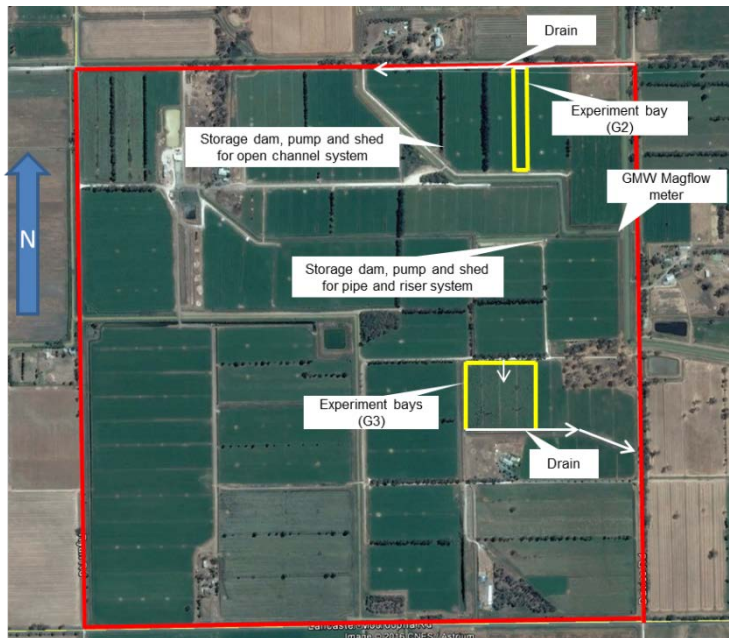
As part of objective 1 the project selected a dairy farm in Northern Victoria to undertake SBIIS irrigation performance pilots in partnership with irrigation automation service providers Rubicon. Rubicon have established irrigation automation incorporating a basic scheduling service on the property as depicted in the figure below.

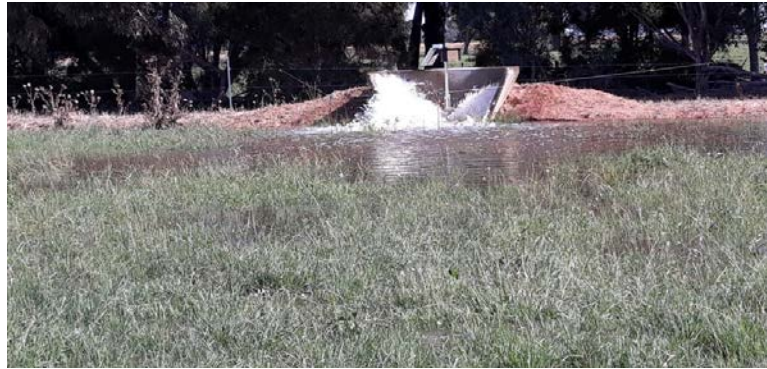
Figure 2: Irrigation in progress on one of the experiment bays at L1

The bays at L1 were irrigated by a pipe and riser irrigation system (Figure 2) while the bay at L2 was irrigated by an open channel irrigation system (Figure 3a). At L2, the bay had three shallow drains (Figure 3b) at approximately equal distance across the bay, these drained the last 50m of the bay. At both locations, automatic irrigation systems installed by Rubicon Water (<http://www.rubiconwater.com>) irrigated the bays. The experimental bays at both locations had an established perennial pasture, grazed by cows.

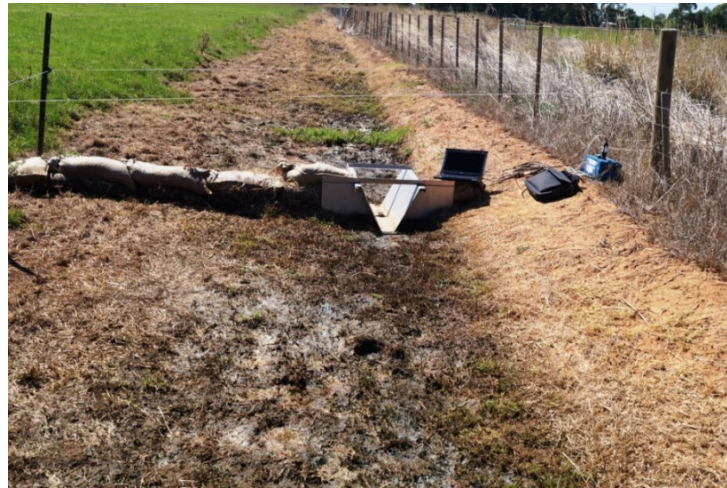
Figure 4: Measurement of runoff at L1

Runoff was measured at both locations to evaluate irrigation performance. At L1, cumulative runoff was measured by using an ISCO flow meter (<http://www.teledyneisco.com>) fitted in a trapezoidal metal frame and installed in the drain after the fourth experiment bay (Figure 4). At L2, runoff was measured by blocking the end of the bay with dirt (Figure 5a) and converging water through the Broad Crested Weir Flumes (Clemmens et al. 2011) installed at the bay end in each shallow drain (Figure 5b). Water depth within each flume was measured by WT-HR logging depth meters and converted to inflow rate by using depth-discharge relationship.

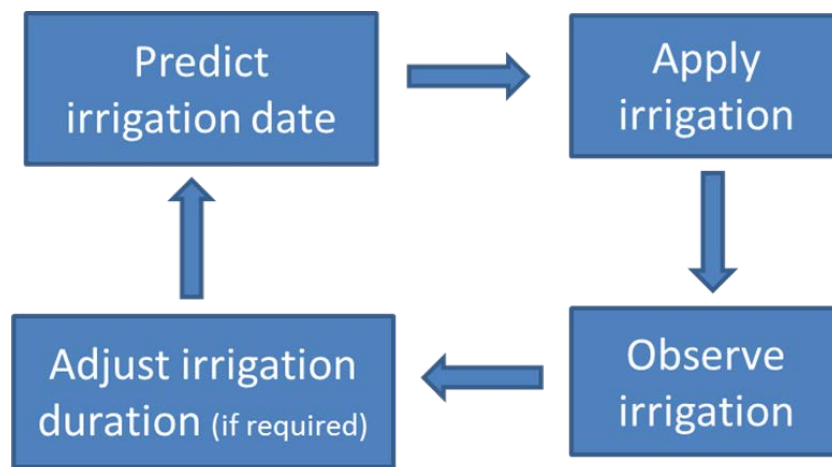
Figure 7: Block diagram of the irrigation scheduling process

A block diagram of the irrigation scheduling process tested on both locations on the farm is shown in Figure 7 and detail is provided below.

1. Predict the date of the next irrigation for crop water requirement (ETc-R) equal to approximately 50 mm.
2. Send an SMS to the irrigator before the irrigation date. Irrigation date or inflow duration will be adjusted if rainfall occurs before the irrigation date. Irrigation duration will also be adjusted if the farmer decides to irrigate on a different date than the predicted date.

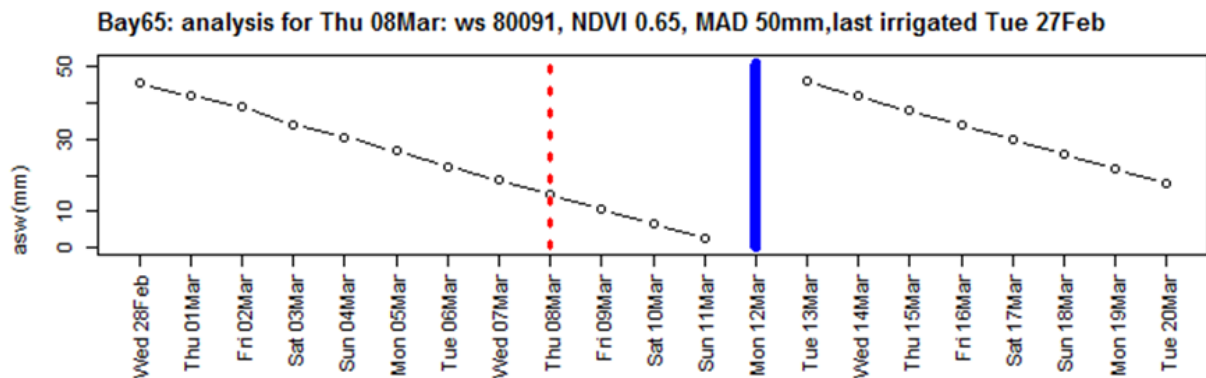
Figure 8: Predicted date of the fourth irrigation at L1

The bays were approximately 48 m wide and 200 m long. At this location, a watertable was found within 2.0 m from the bay surface. Four irrigations were measured at this site. An example of the predicted date of one of the measured irrigations is shown in Figure 8. In this figure, the y-axis is available soil water (asw), ws80091 is the SILO code for Kyabram weather station, and the vertical dotted red line is the date model ran to predict the next irrigation date.

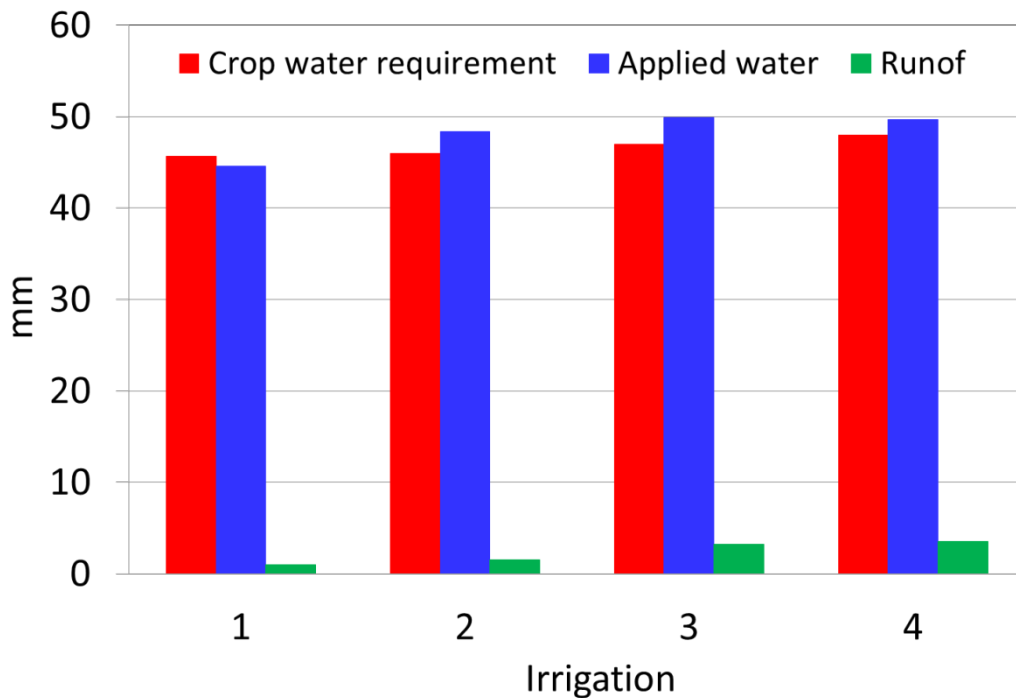
Figure 9: Average crop water requirement, applied water and runoff of each bay at L1

In each irrigation, approximately 3 mm water was added to the crop water requirement of each bay to ensure that water reached the end of the bays. Over the four irrigations, average water applied on each bay ranged from 45 mm to 50 mm to satisfy a 46 to 48 mm crop water requirement (Figure 9). At this site there is likely to be some losses due to deep drainage however this component has not been quantified.

The 2016/17 and 2017/18 results have consistently demonstrated application efficiencies of over 90%.

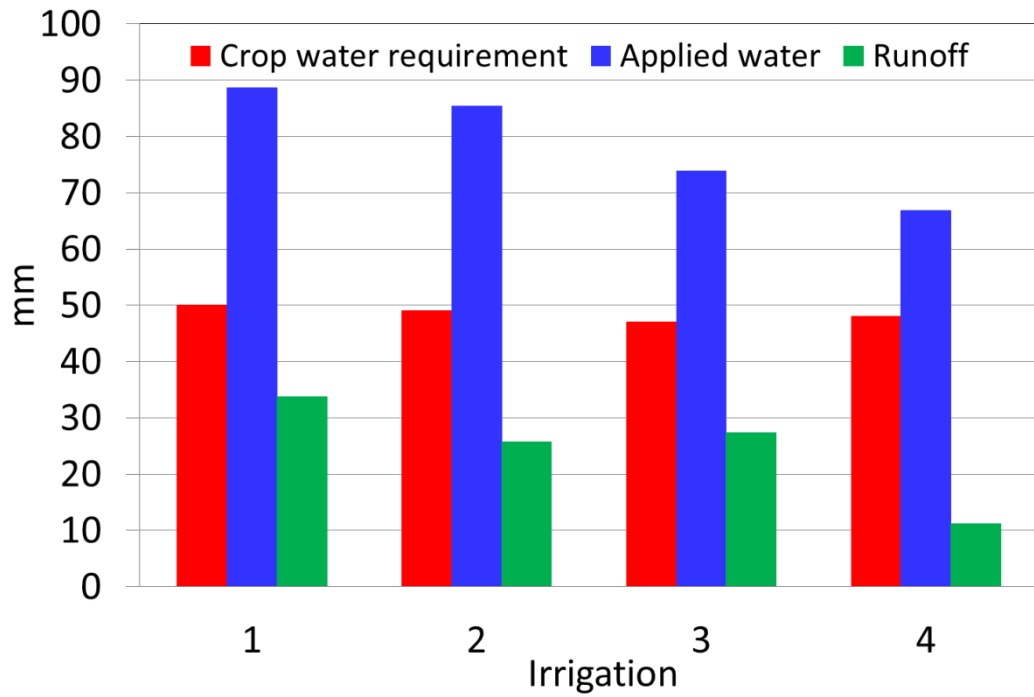
Figure 10: Crop water requirement, applied water and runoff of the bay at L2.

It should also be noted that while application efficiency was low (56%-66%) over the period of the 4 irrigations applied water and runoff was reduced by over 24% and 40% respectively a large improvement in the outcome of the irrigation event.

While application efficiency may be improved with better management of the deficit and duration of the irrigation event the physical limitations of the bay in regards to soils type and shallow drains means application efficiency will always be lower than L1.

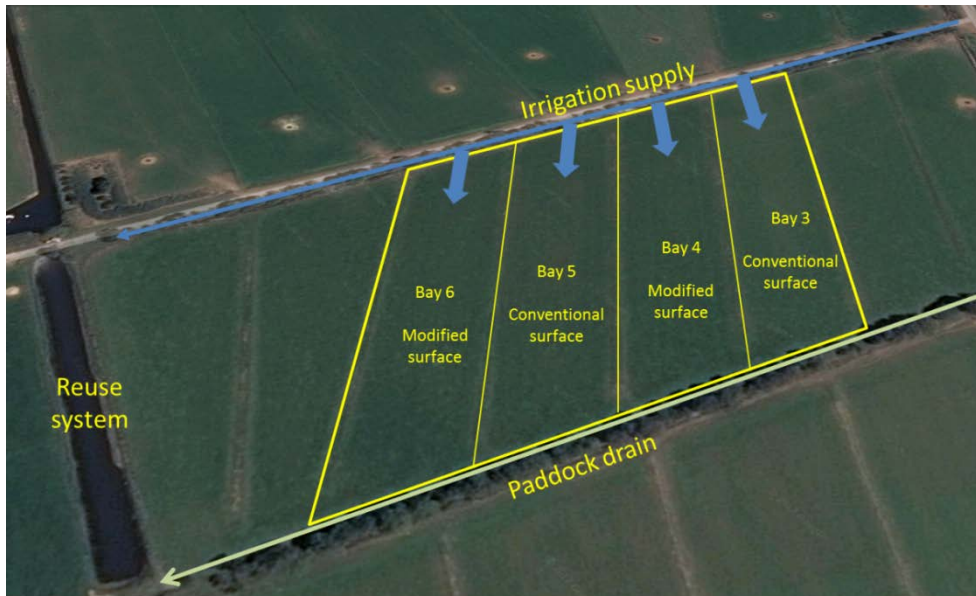
Figure 1: Site layout

Bay	Length (m)	Width (m)	Area (ha)	Average slope (m/m)	Gradient
3	214.5	52.7	1.13	0.002032	1 in 492
4	214.0	53.2	1.14	0.001617	1 in 618
5	212.5	54.2	1.15	0.001700	1 in 588
6	212.5	53.5	1.14	0.001735	1 in 576

The irrigation supply is from a Dethridge wheel meter via a 2km farm channel. A reuse dam adjacent to the demonstration site paddock can provide a more flexible alternate irrigation supply when required. The site drains directly to the reuse dam.

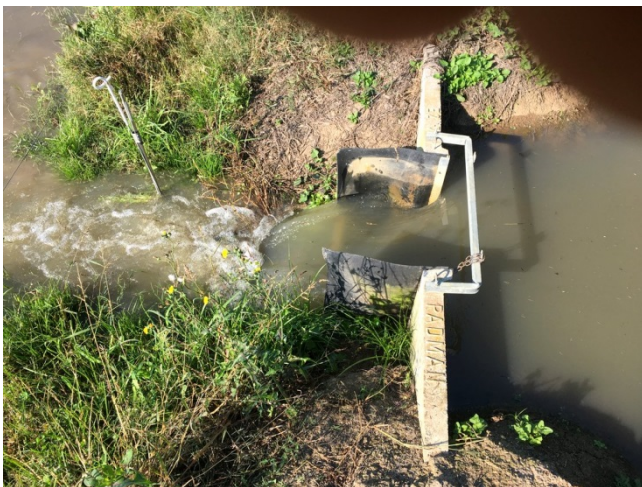
Figure 2: A site bay outlet

Irrigations are controlled with manually operated Padman stops (Figure 2). The bays support an established perennial ryegrass pasture with areas of prior pugging damage (Figure 3).

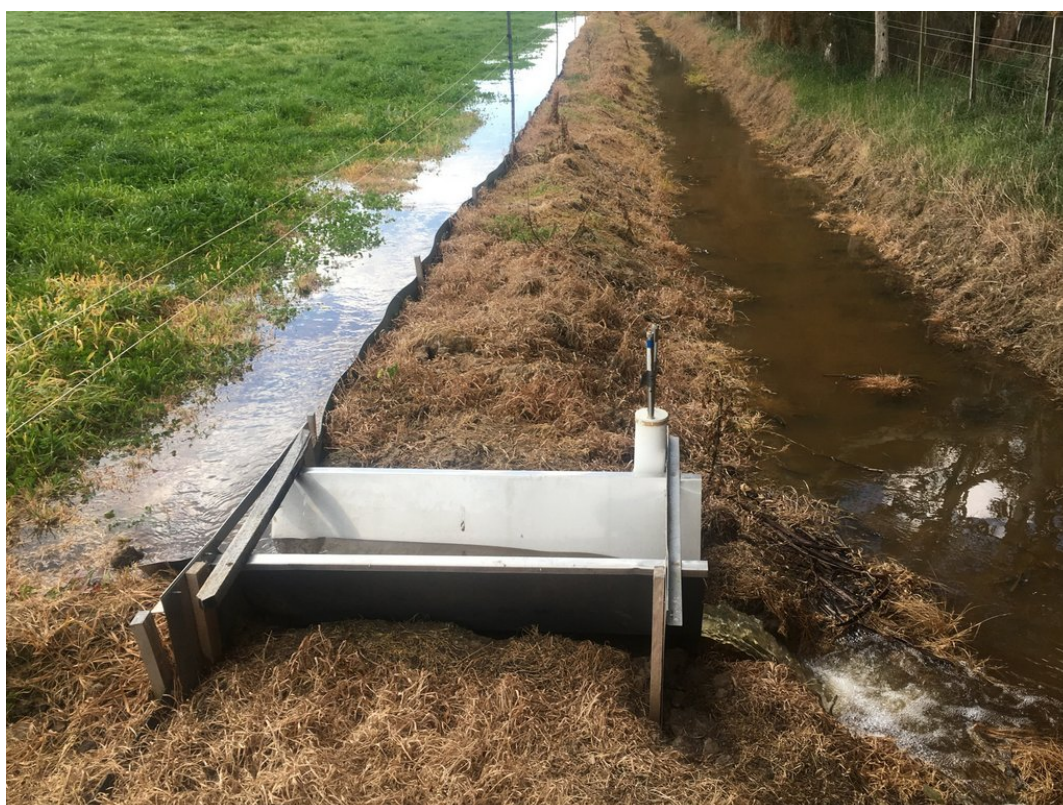
Figure 5: Bay runoff flume

During runoff the bund and flume held back outflow which had the effect of attenuating the runoff hydrograph, however the start time of flow and the volume of flow were accurately measured, provided that the bund did not leak or overtop.

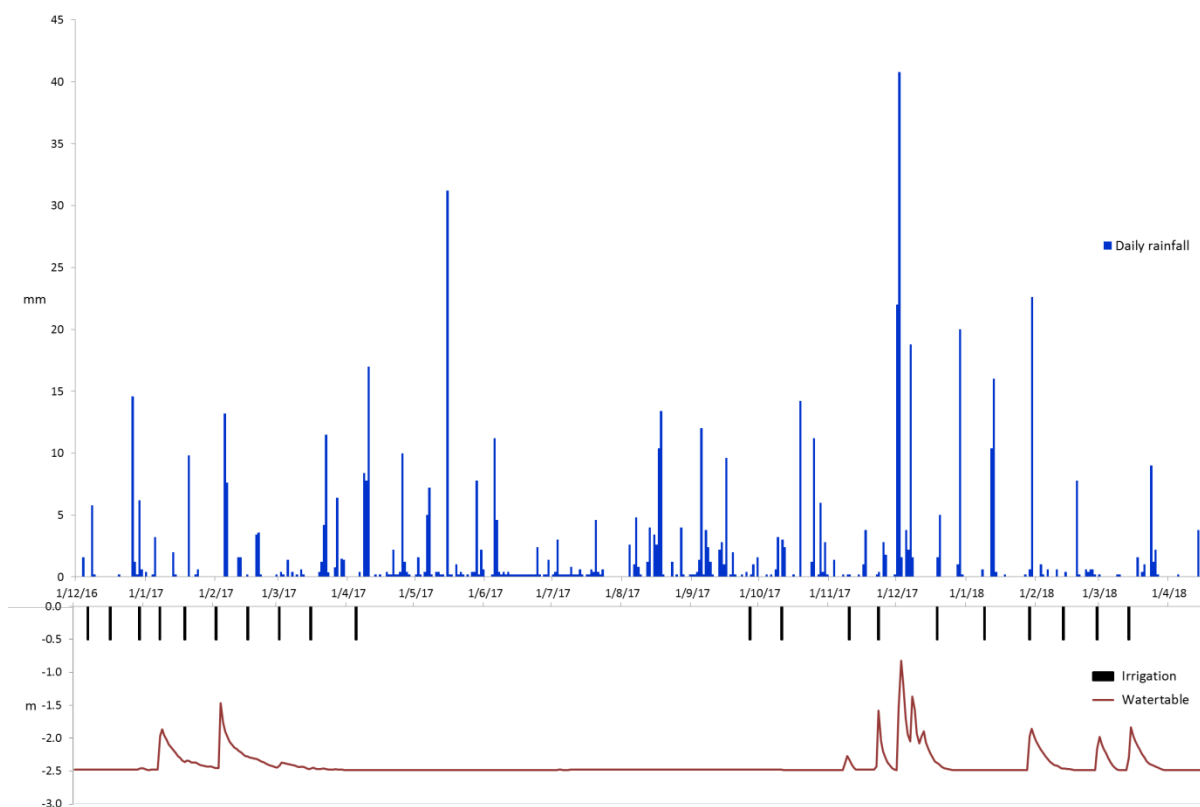
Figure 6: Daily rainfall and watertable depth during the experiment

Figure 6 shows daily rainfall recorded at the experiment site during the project. Of note was the relatively dry winter and spring of 2017. There was only 190 mm of rainfall in the period from 1 June to 30 November, compared with the long term average at Maffra of 275 mm for this period. The dry spell was broken with approximately 90 mm of rainfall in the first week of December 2017.

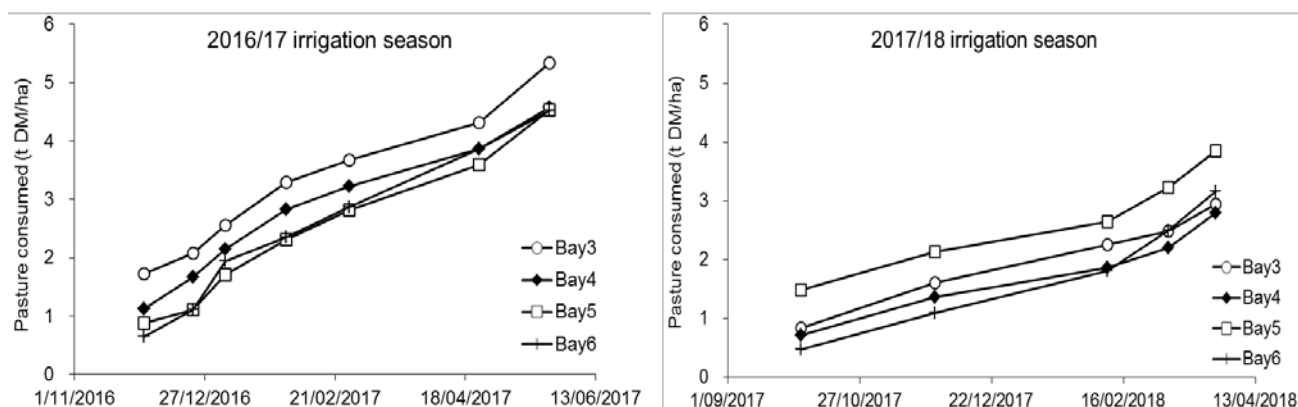
Figure 13: Pasture consumed during the 2016/17 and 2017/18 irrigation seasons

Pasture consumption rate (kg DM/ha/day)				
	Bay 3	Bay 4	Bay 5	Bay 6	Average
2016/17	19.6	18.6	21.4	20.4	20.0
2017/18	11.1	10.5	12.2	14.2	12.0
Average	15.35	14.55	16.8	17.3	16.0

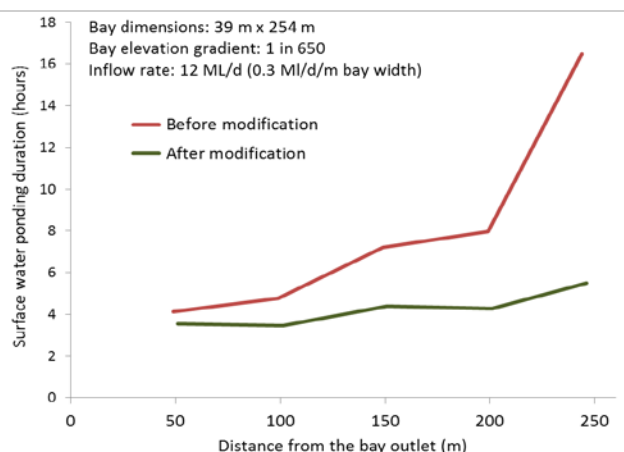
Figure 2: Measured average duration of surface water ponding after border-check irrigation on a bay before and after bay surface modification

We then repeated the measurements after installing the bay modification (Figure 2).

With the surface drains installed, all areas of the bay received a similar irrigation and experienced shorter durations of surface water ponding. The irrigation schedule for this bay could be optimized and be optimal for the whole bay.

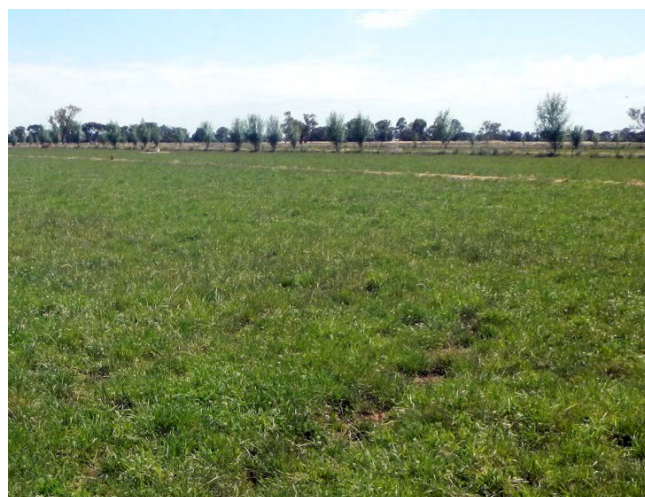
Figure 1: The measured irrigation bay

In 2016 we measured residual surface water after irrigating a one hectare perennial pasture bay. The bay had been laser landformed in the previous year and the bay surface at the time of measurement looked in excellent condition. The new pasture was not yet fully established (Figure 1). The measured durations of surface water ponding at different distances down the bay are summarised in Figure 2. The much longer duration of inundation experienced at the bottom end of the bay is a characteristic of conventional bays due to slow drainage of the excess surface water from higher in the bay. The effect is more pronounced on longer, flatter bays with dense pasture and low permeability soils.

Figure 5 shows the effect on ponding duration that the drains had on the bay shown in Figures 1 and 2. After modification the duration of surface water ponding was much more uniform down the length of the bay and substantially less at the bottom of the bay.

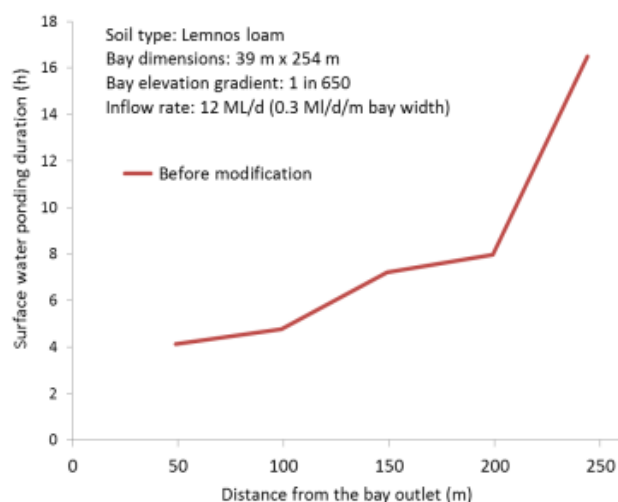
Figure 2: Measured duration of water ponding on a conventional bay after a border-check irrigation

duration of saturation in the rootzone each irrigation. This can reduce root zone oxygen, stressing pasture and crop species while favoring weeds adapted to waterlogging. Longer periods of root zone saturation also increase vulnerability to damage by stock and machinery.

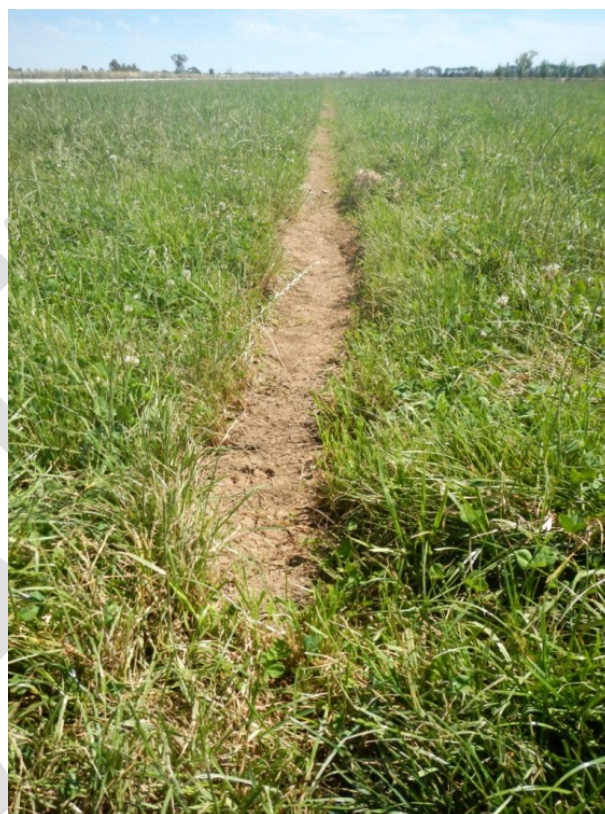
Figure 3: Shallow surface drain installed on a pasture bay

With the surface drains installed, all areas of the bay received a similar irrigation and experienced shorter durations of surface water ponding. The irrigation schedule for this bay can now be optimized and will be optimal for the whole bay.

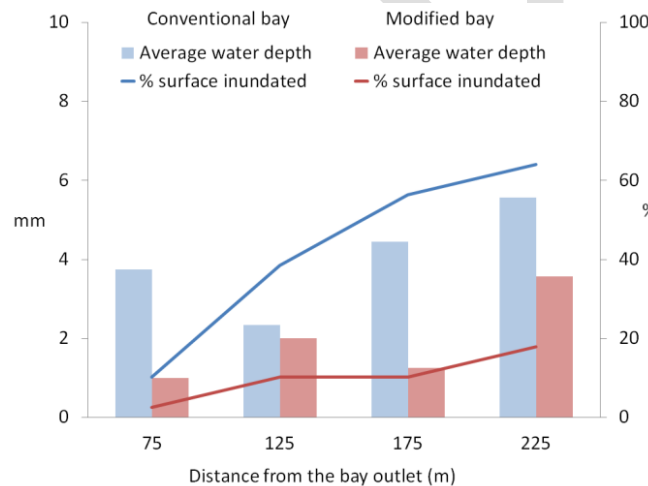
Figure 6: Surface water depth measured on transects across the bay 9 hours after inundation

Figure 6 shows the results of measurements made of water depth at 1 metre intervals on transects across the same bay before and after the modification. The measurements were made approximately 9 hours after initial inundation on transects at 75, 125, 175 and 225 metres from the top of the bay.

Prior to modification, 60% of the bottom half of the bay remained inundated after 9 hours to an average depth of 4 to 6 mm. After modification less than 20% of the bay surface was still inundated after 9 hours, to an average depth of 1 to 4 mm.

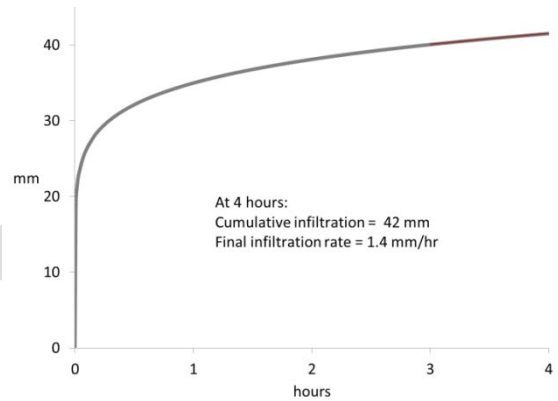
Figure 7: Typical cumulative infiltration curve on the bay that was modified

Typical cumulative infiltration on this bay is shown in Figure 7. The bay soil profile infiltration curve has a shape that is characteristic of cracking soils like Lemnos loam<sup>[3][4]</sup>. On the basis of this curve, the modified bay was inundated for 4 to 5 hours and infiltrated between 41 and 43 mm as a result of the irrigation, while the conventional bay was inundated for between 4 and 16 hours and infiltrated between 42 and 49 mm.

In this instance, the estimated reduction in infiltration due to the bay surface modification was about 4% of the volume of irrigation water applied.

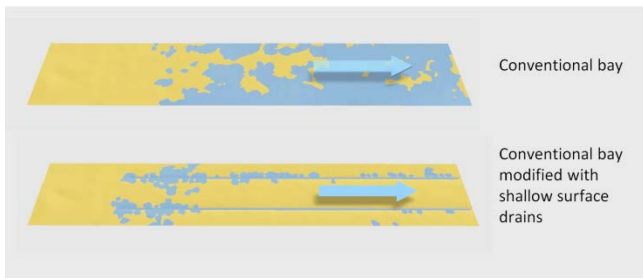
Figure 8: Model output for conventional and modified bay surfaces at 5 hours after the start of the same simulated irrigation

The simple modification described here was the stand-out of all the bay modifications we tested, achieving rapid surface drainage and high irrigation uniformity.

Importantly, our computer simulations indicated that this bay modification is very robust and will work well on a wide range of bay slopes, dimensions, inflow rates, surface roughness and soil types, reducing both the ponding duration and the variation in ponding duration within irrigation bays. It will have greatest effect on flatter bays with relatively low permeability soils.
