NATIONAL PROGRAM FOR SUSTAINABLE IRRIGATION

PROJECT UAD25

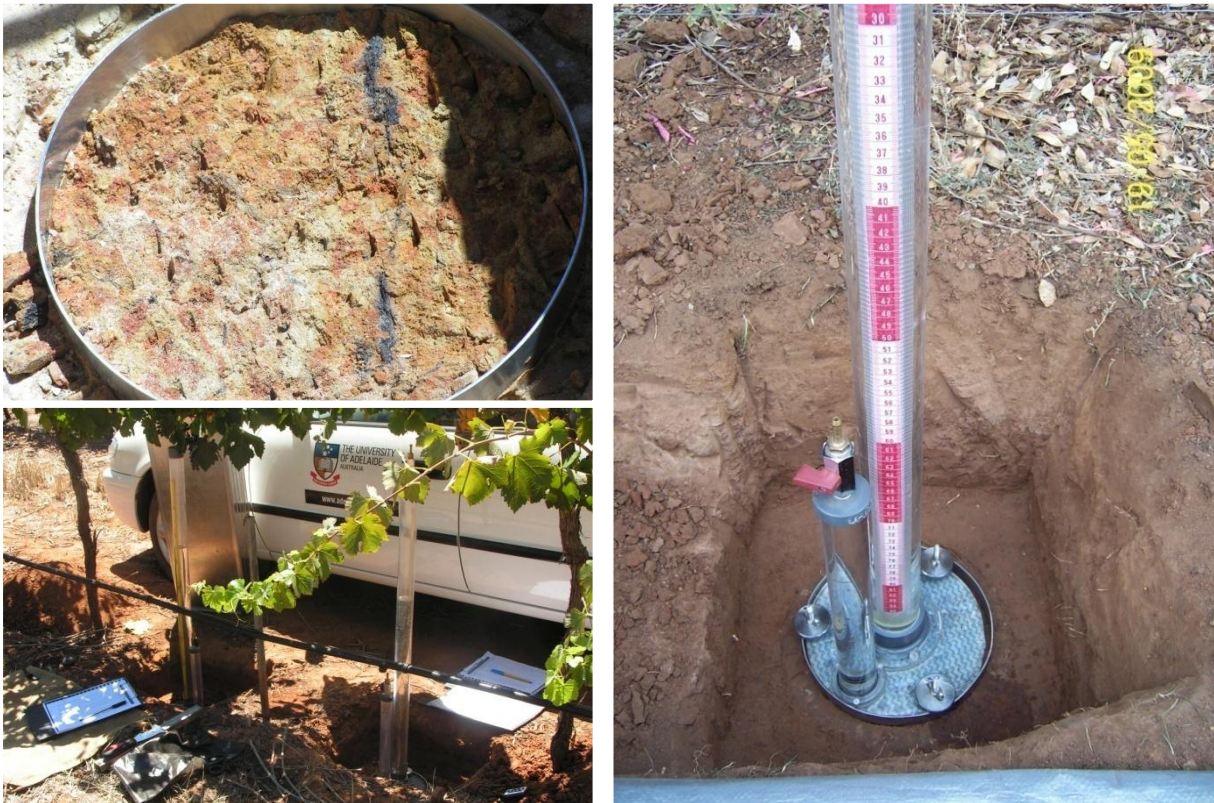
Infiltration rate measurement (clockwise from top left): a subsoil surface prepared for measurement, levelled permeameter in place ready to commence measurement, simultaneous measurements underway directly beneath and mid-way between well-spaced (2 metres) drippers.

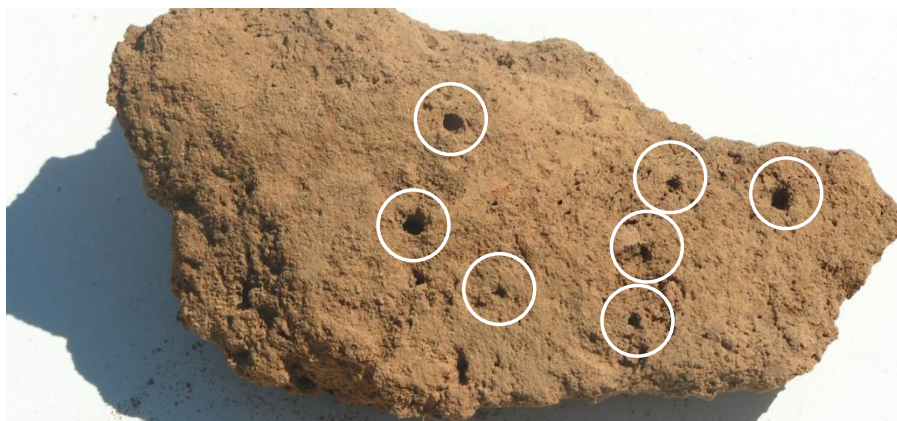
Macropores in a subsoil clod from a Red Chromosol at Tanunda. Continuous macropores promote infiltration, relieve anoxia in the surrounding soil matrix and provide pathways for root growth.

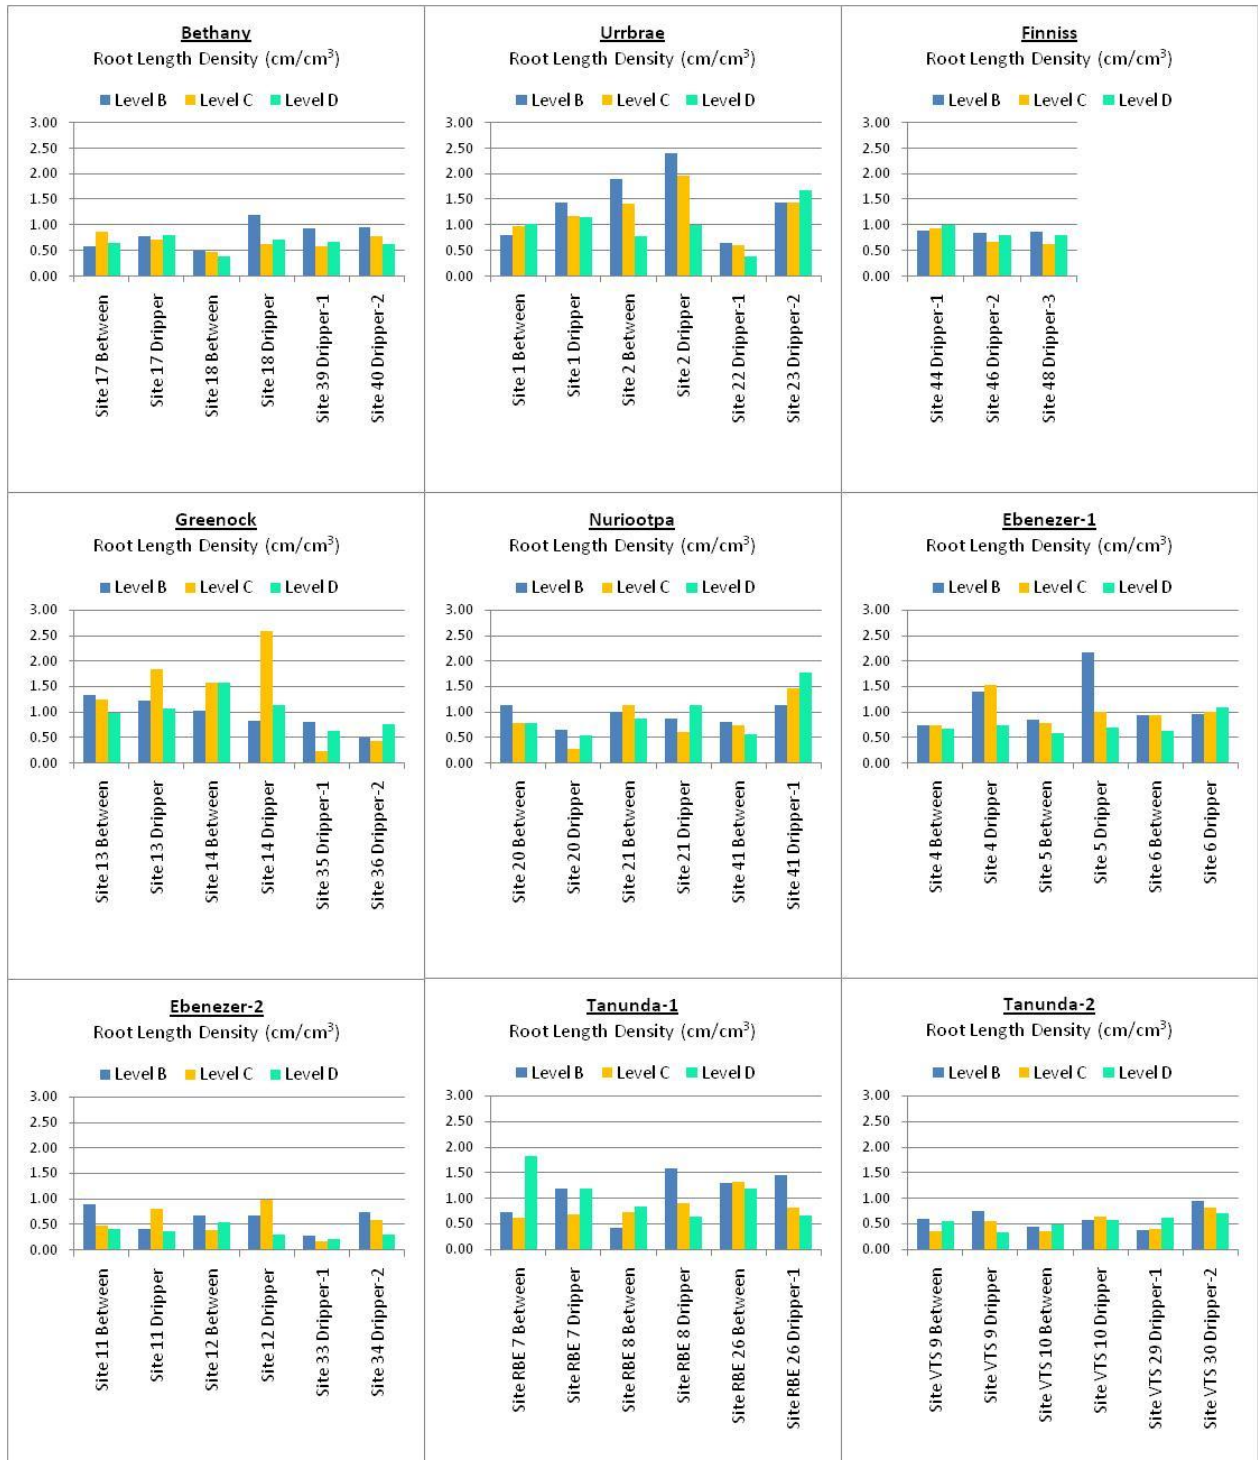
Figure 12: Root length densities (cm/cm³) at 3 depths (mean of 4 replicates each) at 51 sites in 9 vineyards. Levels B,C,D refer to Figure 11.

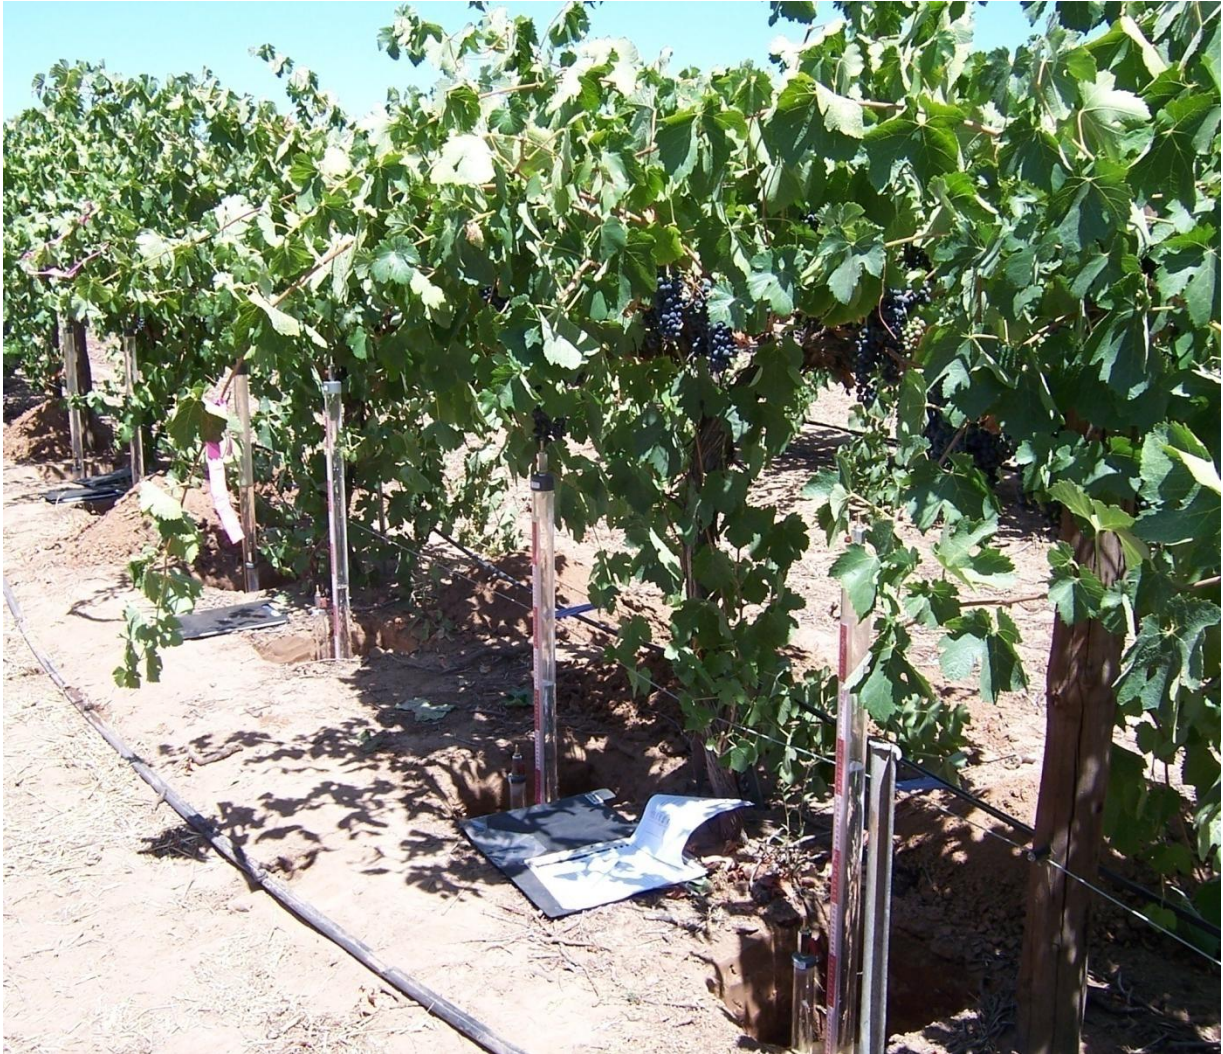
Six subsoil infiltration measurements underway in a partial rootzone drying (PRD) trial at Nuriootpa in the Barossa Valley. The “wet” and “dry” sides of vines alternate along the vine row; 3 measurements were made at positions that had not been irrigated for an entire growing season and 3 at positions that had been irrigated normally.
