# Pump Cavitation

## Improving Energy Efficiency on Irrigated Australian Cotton Farms

### Cavitation in pumps

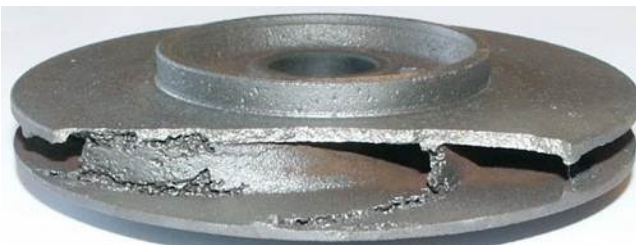
The process of cavitation occurs when the vacuum pressure (also called suction pressure) in the water entering a pump falls below the vacuum pressure at which vapour bubbles form. In other words, the suction pressure at the pump intake is so great that vapour bubbles form in the water. These vapour bubbles move through the pump to the high pressure regions against the pump impeller. The vapour bubbles, which were formed under a vacuum pressure, then collapse, or 'implode' against the impeller. Each bubble implosion will actually eat a small hole in the impeller. Further bubble implosions will occur at these holes and continue to physically scour the impeller causing localised damage (figure 1). These are often referred to as 'worm holes'.

**Figure 1 :** Cavitation damage to an impellor (Wikicommons – User:Benutzer:Klausbärbel)

Cavitation damage has a different appearance to damage caused by pumping sand or gravel, which will make the entire surface of the impeller evenly worn and shiny, as if it has been cleaned by sand paper. Cavitation does sound like sand or gravel is being pumped.

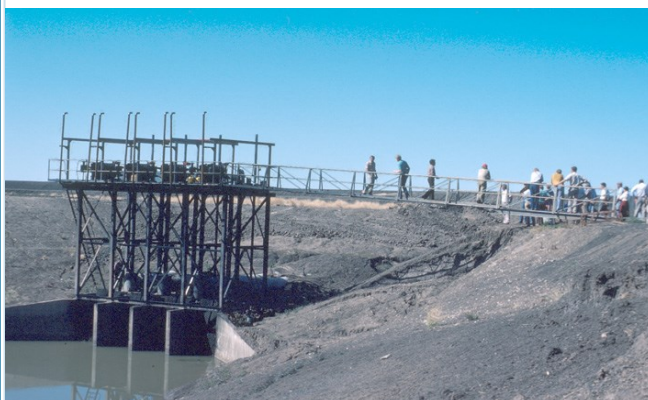
Older pump station designs sensibly placed these large mixed flow pumps at or below the incoming water surface level. These older designs have no potential to cavitate because they are placed close to the incoming water surface level.

**Figure 2 :** Older style pump station installations in the Australian cotton industry (R.J. Smith).

Over the last decade a trend has arisen in large pump station designs in the Australian cotton industry where pumps are placed high above the incoming water surface. This configuration leads to pump cavitation in most cases.
